RE: Indow Windows  
Field Sound Transmission Loss Testing

The following report was prepared as part of an Industry Research project BSCI 9750, Graduate Program in Building Science, supported by the British Columbia Institute of Technology (BCIT), Centre for Architectural Ecology. The report provides a summary of completed field sound transmission loss testing of an installed tilt-and-turn window with various insulated glass unit (IGU) configurations and an interior storm window, provided by Indow Window installed over the baseline IGUs.

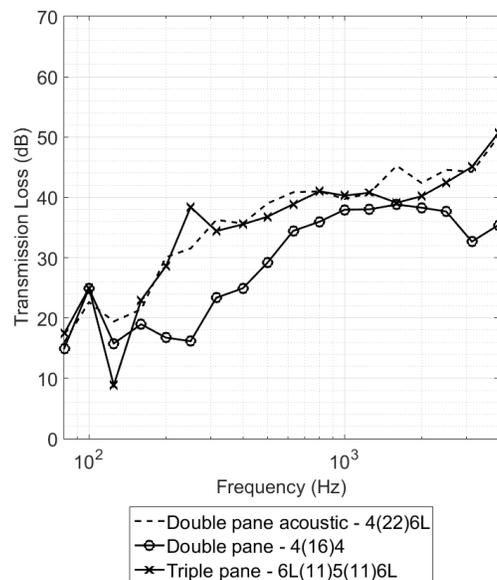
Figure 1: Sound transmission loss data for various IGU configurations: double pane – acoustic, 4(22)6L, (Dotted Line), double pane, 4(16)4, (Symbol “o” + Line), and triple pane, 6L(11)5(11)6L, (Symbol “x” + Line)

The test results are consistent with trends from published transmission loss data. As expected, when comparing between the two double-pane IGUs, the *double pane-acoustic* exhibits consistently higher

transmission loss across all frequencies. This can be attributed to the combined effect of increased glazing thickness of one of the panes, increased air space between the IGU, as well as the different glass composition, an upgrade laminated for the thicker pane. The triple glazed IGU has acoustic advantages over the *double pane* above 160 Hz. However, the triple pane has almost identical transmission loss data to the *double pane-acoustic*, only showing marginal benefits around 200 to 315 Hz and above 3.15 kHz. Thus, the interior storm window was studied only on the two double-paned IGU configurations.

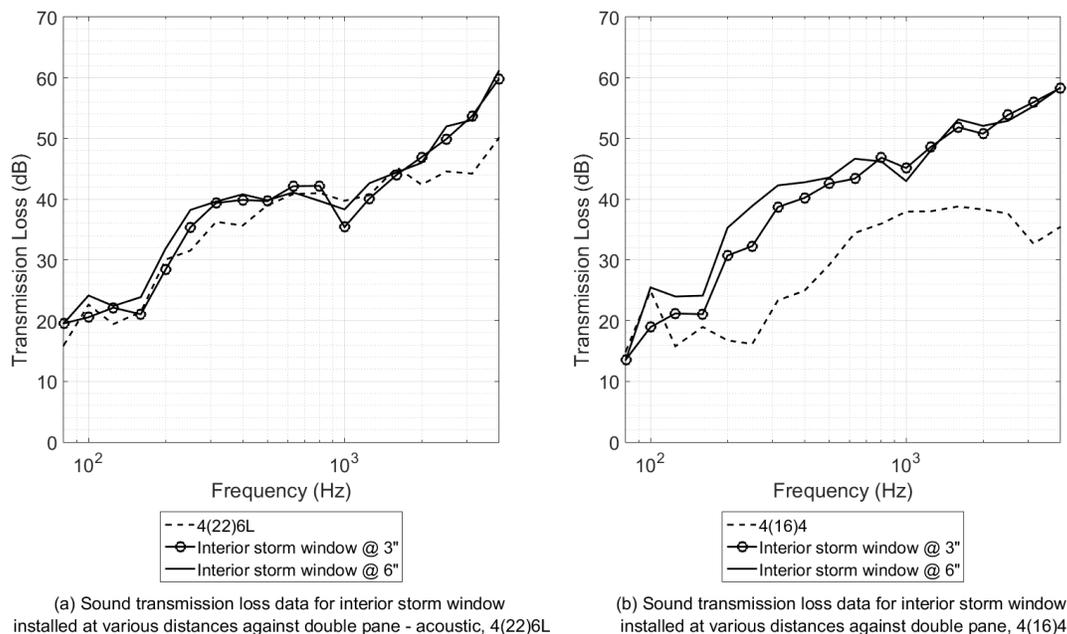
Figure 2: Sound transmission loss data with interior storm window at 3" (Symbol "o" + Line) and 6" (Solid Line) depth against double pane – acoustic and double pane IGU configurations

The acoustic performance of the interior storm window was tested at two different distances, with enclosed air spaces depth of 3" and 6". Figure 2 illustrates the measured sound transmission loss values of the interior storm window on the two double IGU window variations at the two distances.

When used with the higher performance *double pane – acoustic* window, the interior storm window has minor increase sound transmission loss at mid and high frequencies. The introduction of deeper enclosed airspace has much the same effect on the acoustic performance as the one with the shallower airspace.

When used with the *double pane* window, the deeper airspace between the interior storm window and primary window can contribute to additional sound transmission loss in the low to mid frequencies. At higher frequencies, the larger air space provides minimal advantage over the shallower airspace. Regardless of the installation placement distance from the primary window, the interior storm window provides appreciable noise reduction when it is installed over the *double pane* window, and significantly improved the overall sound insulation of the base window. At both 3" and 6" depth, the average sound insulation improvement, across frequency bands between 125 to 4k Hz, is approximately 14 dB.

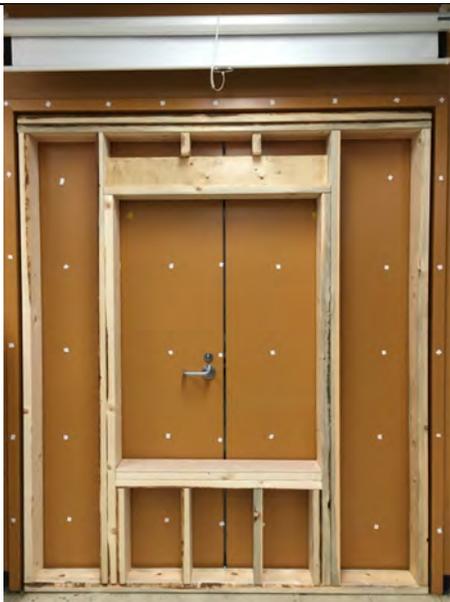
<p><b>PHOTO 2:</b> Wood Framing for Insert Test Panel</p>

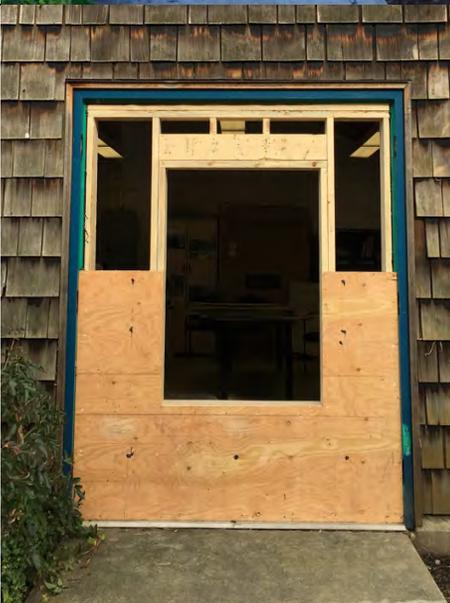
<p><b>PHOTO 3:</b> Exterior Plywood Installed on Frame</p>

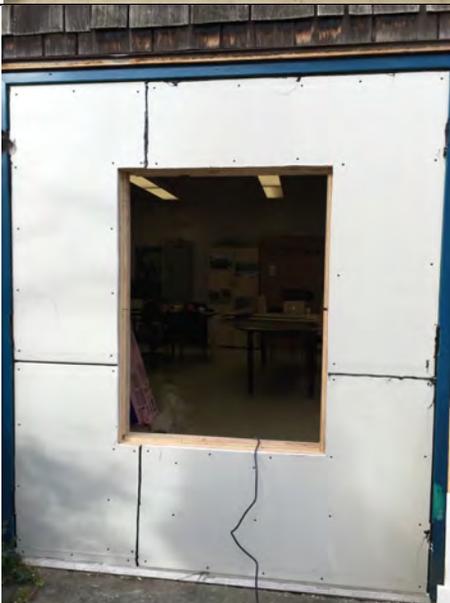
<p><b>PHOTO 4:</b> 1<sup>st</sup> Layer of GWB on Plywood</p>

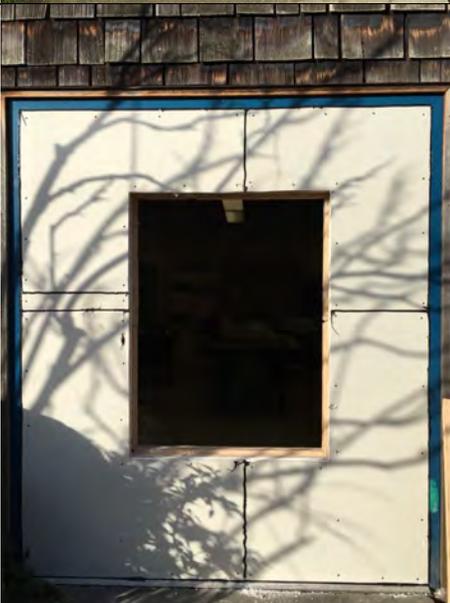
<p><b>PHOTO 5:</b> 2<sup>nd</sup> Layer of GWB on Plywood</p>

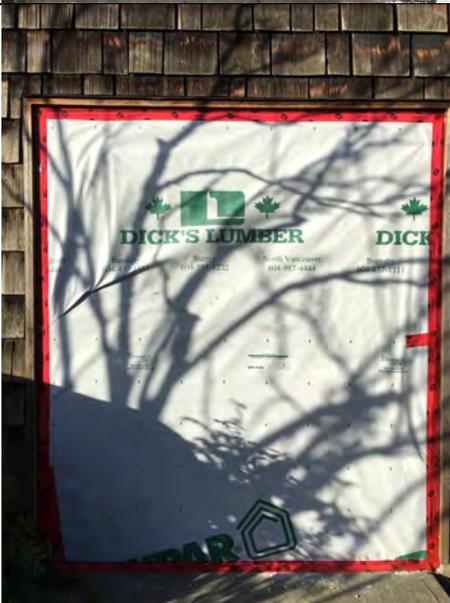
<p><b>PHOTO 6:</b> Tyvek over GWB &amp; Plywood on Frame</p>

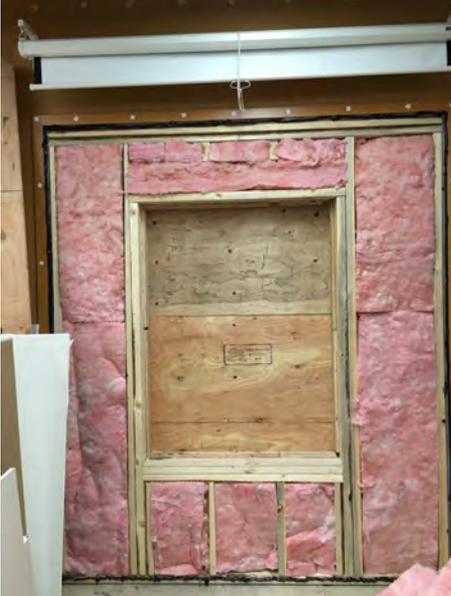
<p>PHOTO 7: Batt Insulation in Wood Frame Cavity</p>

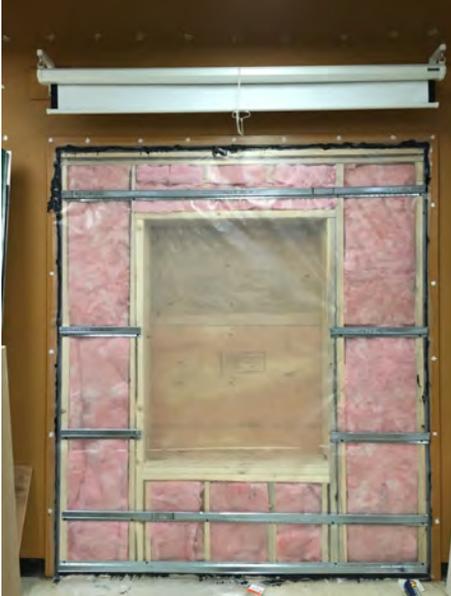
<p>PHOTO 8: Polyethylene Sheet &amp; Resilient Channels</p>

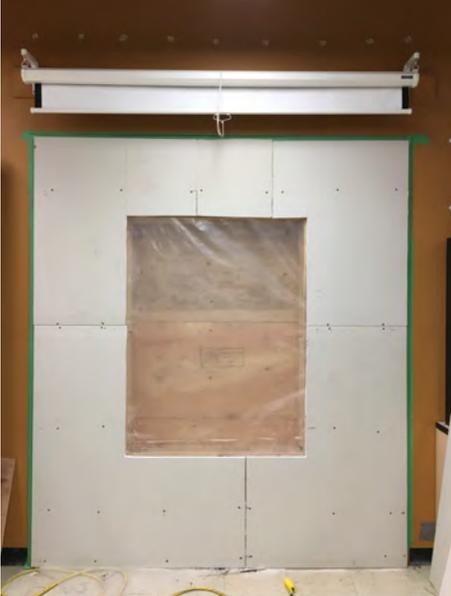
<p>PHOTO 9: Interior GWB on Resilient Channels</p>

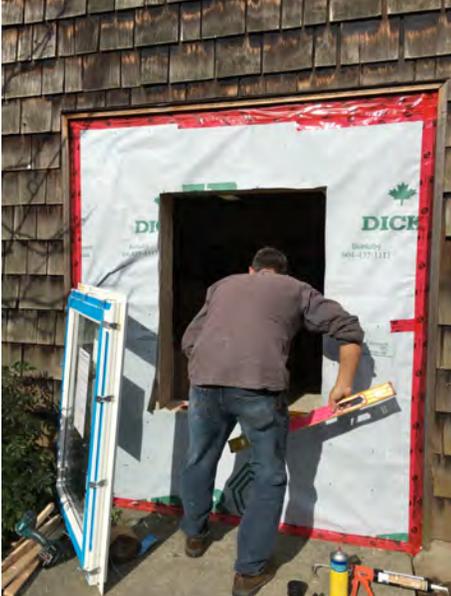
<p>PHOTO 10: Window Installation</p>

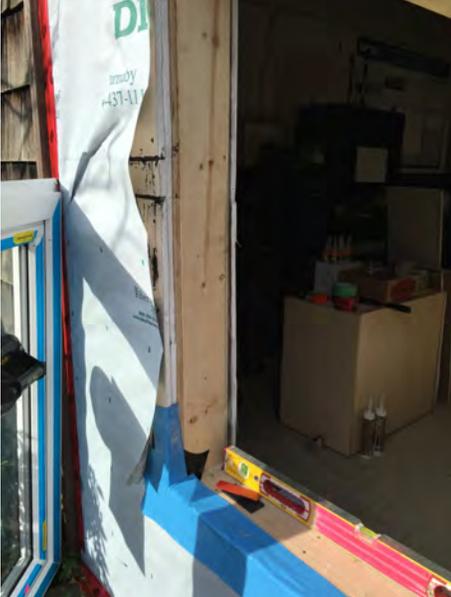
<p>PHOTO 11: Window Rough Opening</p>

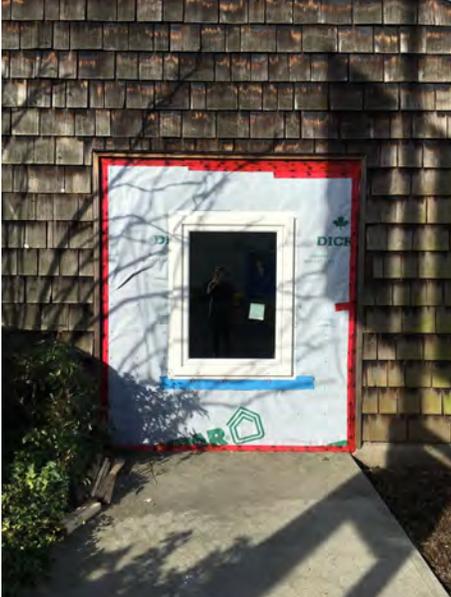
<p>PHOTO 12: Installed Window at Insert Test Panel</p>

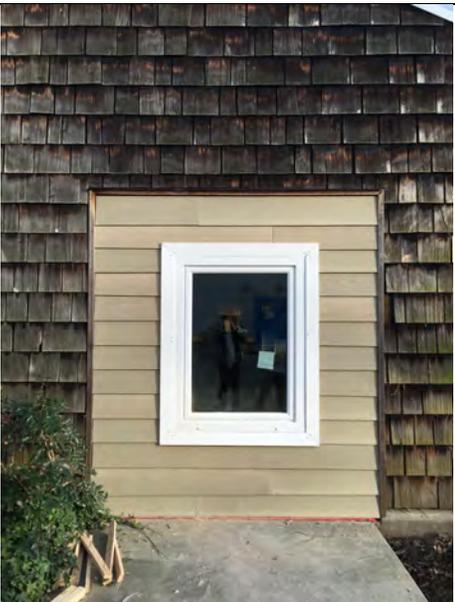
<p>PHOTO 13: Horizontally Lapped Siding on Test Panel</p>

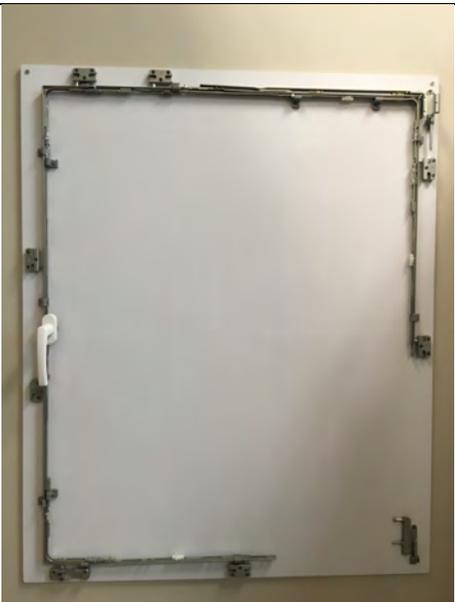
<p>PHOTO 14: Tilt &amp; Turn Operation Mechanism</p>

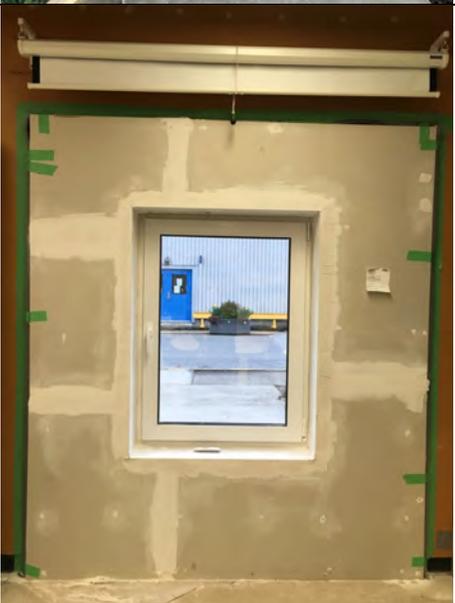
<p>PHOTO 15: Drywall Return at Window Opening</p>

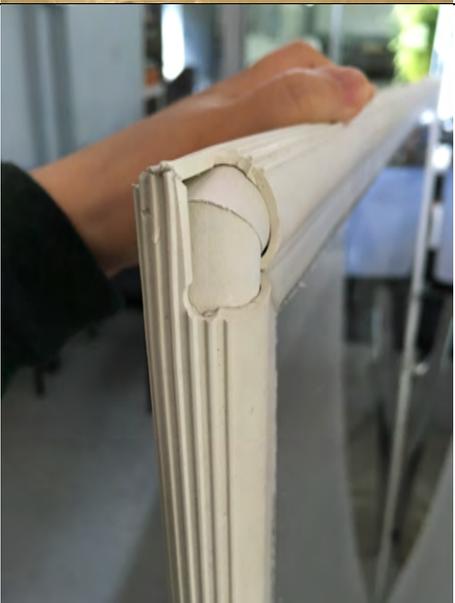
<p>PHOTO 17: Interior Storm Window (Silicone Edge Seal)</p>

The interior storm window is a secondary window that is installed on the interior side of the existing primary window. The Indow interior storm window consist of a ¼" acrylic glazing panel edge with ridged ABS plastic carrier with a hollow silicone bulb. The panel size is approximately 35.5" wide and 47" tall.

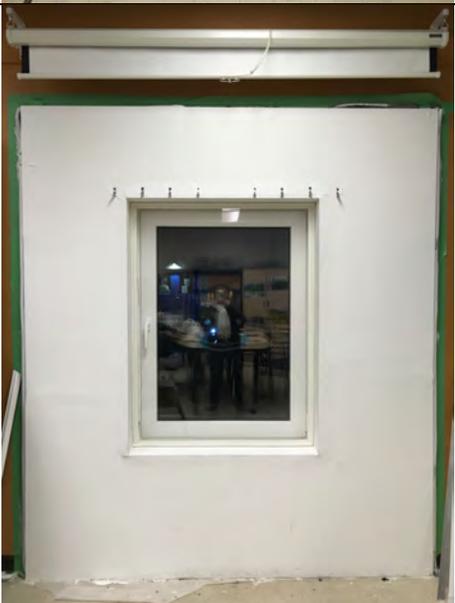
<p>PHOTO 18: Installed Interior Storm Window</p>

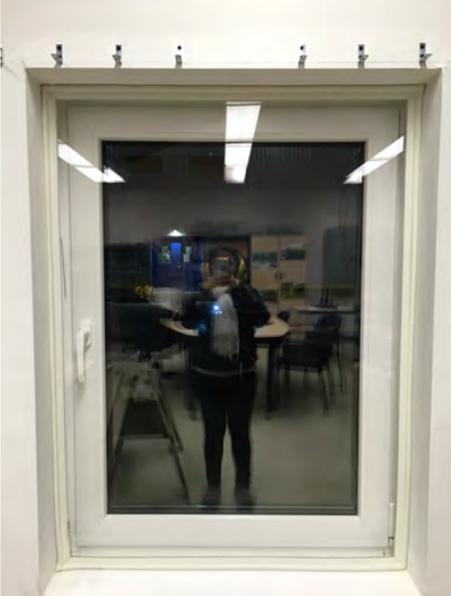
<p>PHOTO 19: Installed Interior Storm Window, Close-up</p>

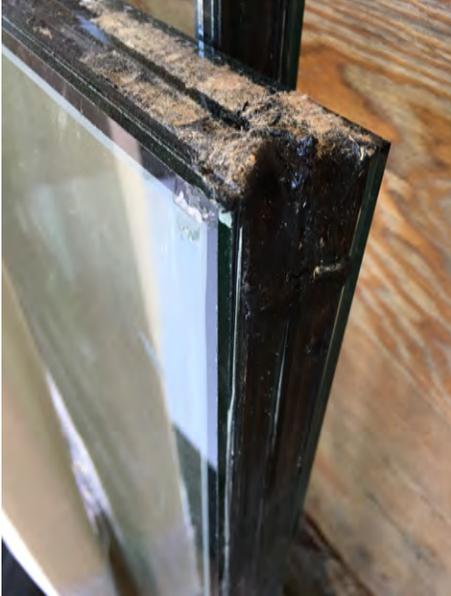
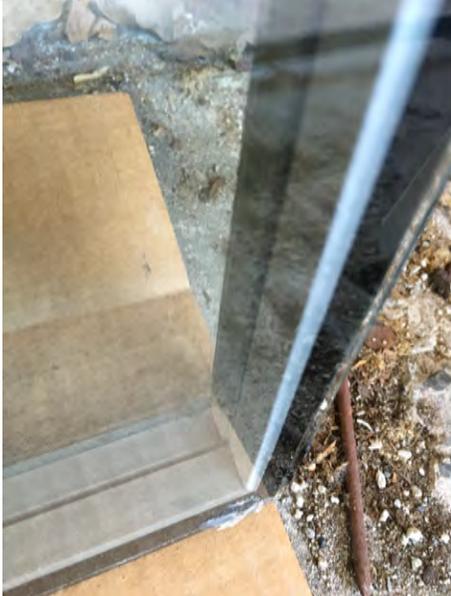
A photograph showing the corner of a room where an interior storm window is installed. The window is white and fits into a white frame. The corner of the room is visible, showing the wall and ceiling. The window is secured with metal fasteners.
<p>PHOTO 21: Tripe Pane IGU, 6L(11)5(11)6L</p>

A close-up photograph of a triple-pane insulated glass unit (IGU). The unit is set in a dark frame. The three panes are visible, with a dark spacer between them. The unit is mounted on a wooden surface.	<p>PHOTO 22: Tripe Pane IGU, 6L(11)5(11)6L</p>

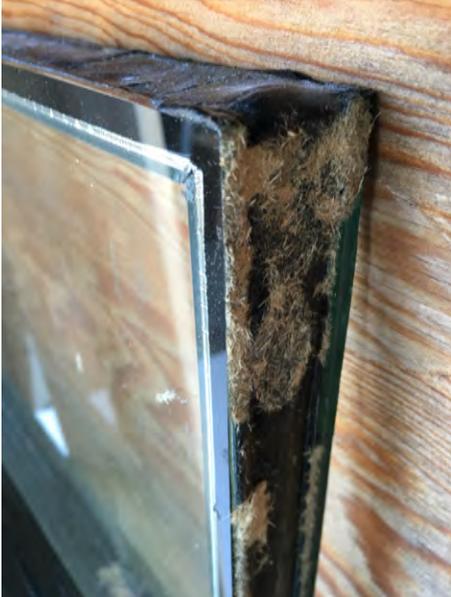
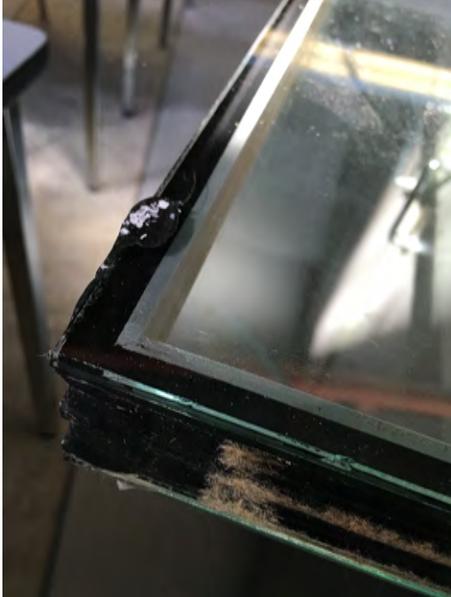
<p>PHOTO 23: Double Pane IGU, 4(22)6L</p>

A close-up photograph of a double-pane insulated glass unit (IGU). The unit is set in a dark frame. The two panes are visible, with a dark spacer between them. The unit is mounted on a wooden surface.	<p>PHOTO 24: Double Pane IGU, 4(22)6L</p>

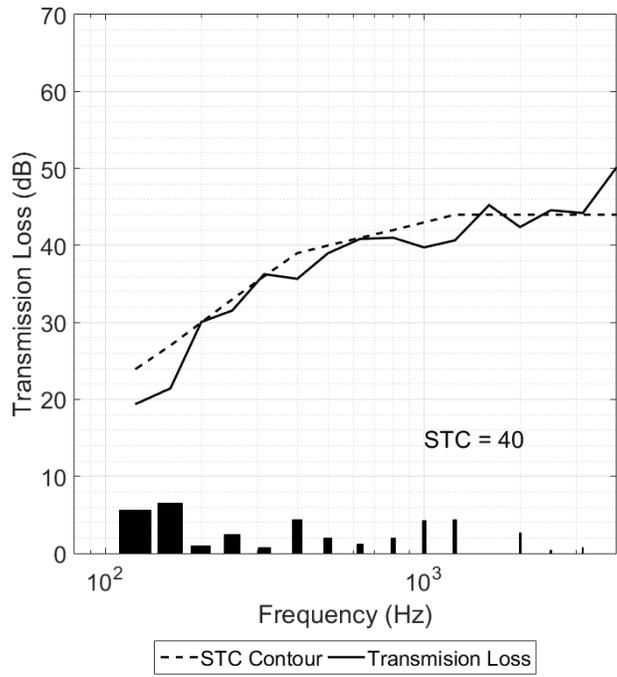
Figure 1: STC Reference Contour (Dotted Line) Fitted to Sound Transmission Loss data of Double Pane – Acoustic window, 4(22)6L (Solid Line)

summarized in Table 1 below. The change in transmission loss, STC, and OITC ratings between the interior storm window and the baseline IGUs are presented in Table 2. The STC reference contour is aligned with the transmission loss data for all baseline windows and the addition of the interior storm window at two distances and can be found in Appendix C.

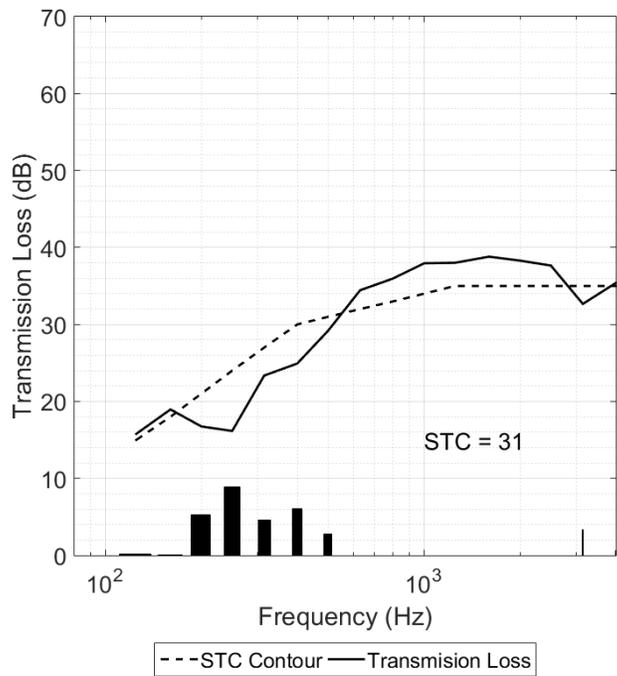
Figure 2: STC Reference Contour (Dotted Line) Fitted to Sound Transmission Loss data of Double Pane window, 4(16)4 (Solid Line)

Note: The deficiencies are shown as bars at the bottom of the chart. The 8-dB limitation is not invoked.

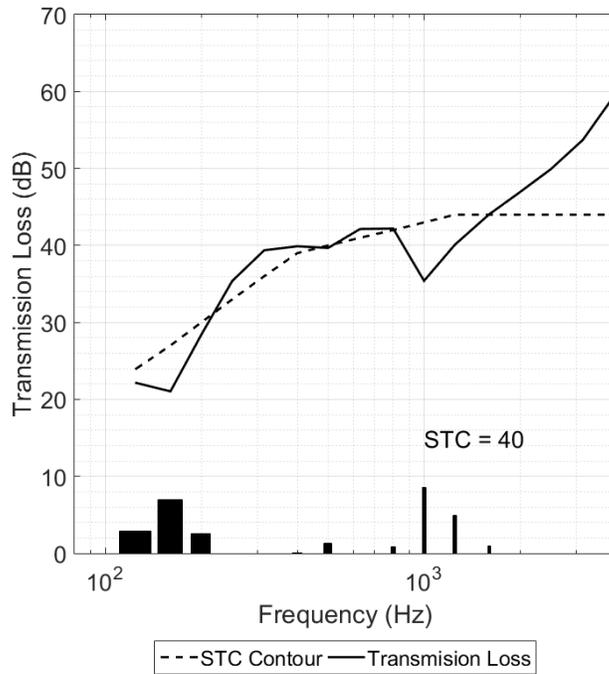
Figure 3: STC Reference Contour (Dotted Line) Fitted to Sound Transmission Loss data of Interior Storm Window @ 3" on Double Pane – Acoustic window, 4(22)6L (Solid Line)

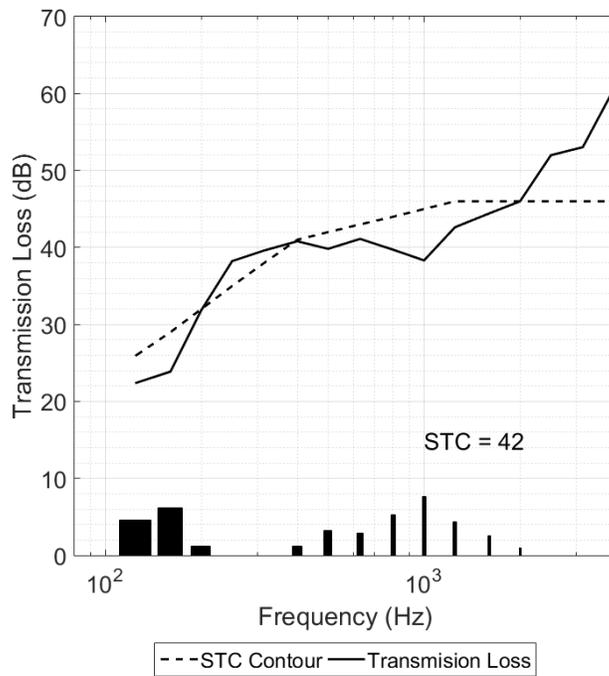
Figure 4: STC Reference Contour (Dotted Line) Fitted to Sound Transmission Loss data of Interior Storm Window @ 6" on Double Pane – Acoustic window, 4(22)6L (Solid Line)

Note: The deficiencies are shown as bars at the bottom of the chart. The 8-dB limitation is not invoked.

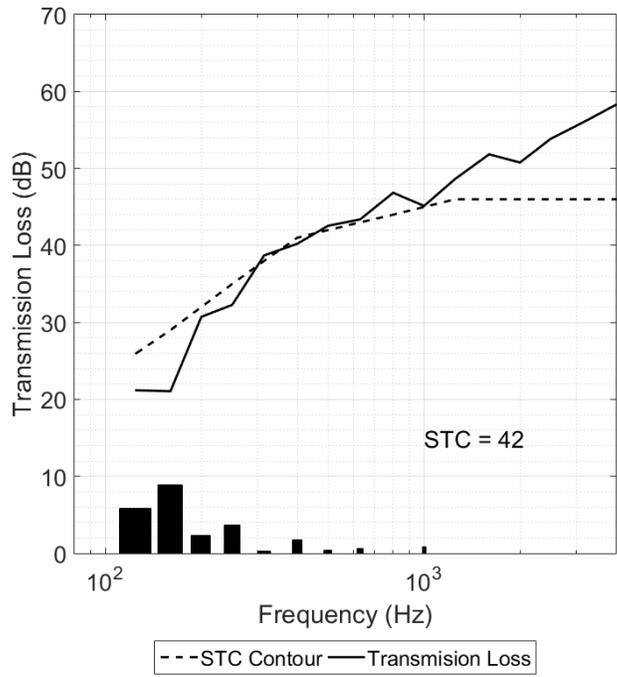
Figure 5: STC Reference Contour (Dotted Line) Fitted to Sound Transmission Loss data of Interior Storm Window @ 3" on Double Pane window, 4(16)4 (Solid Line)

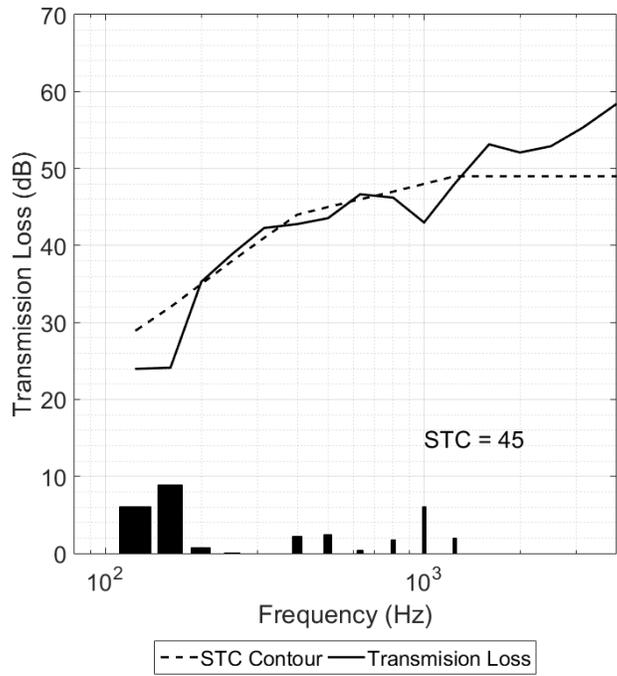
Figure 6: STC Reference Contour (Dotted Line) Fitted to Sound Transmission Loss data of Interior Storm Window @ 6" on Double Pane window, 4(16)4 (Solid Line)

Note: The deficiencies are shown as bars at the bottom of the chart. The 8-dB limitation is not invoked.
